SOUTH TACOMA FIELD
TACOMA, WA

**POST-REMEDIATION ACTION
SITE CONDITIONS**

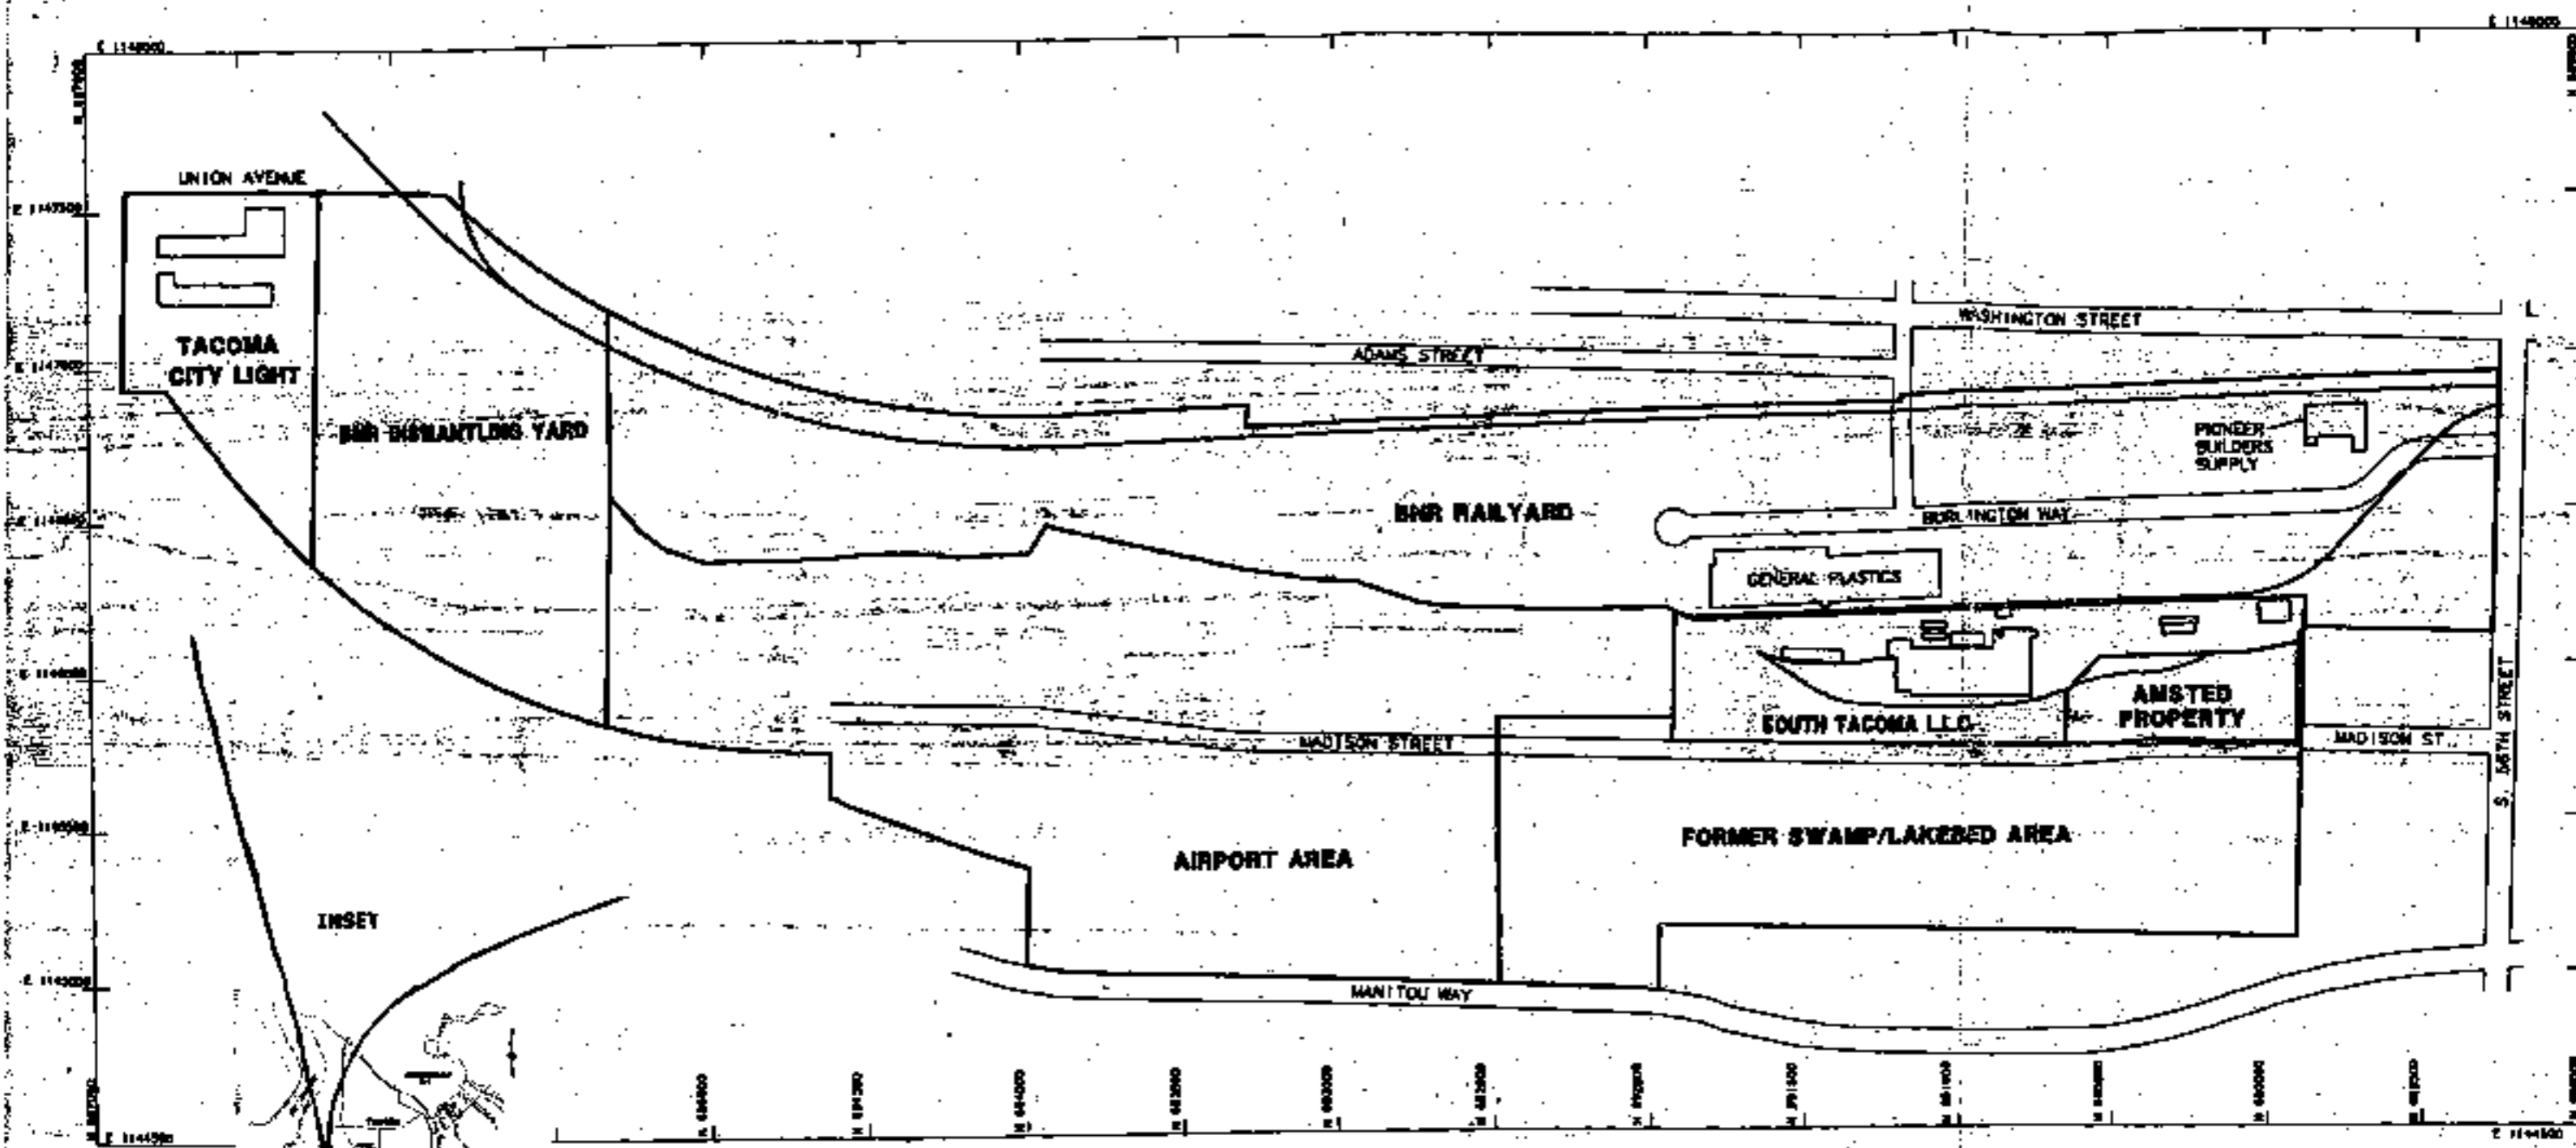
Figure 2

SAMPLING UNIT DESIGNATIONS
AT THE STF SITE

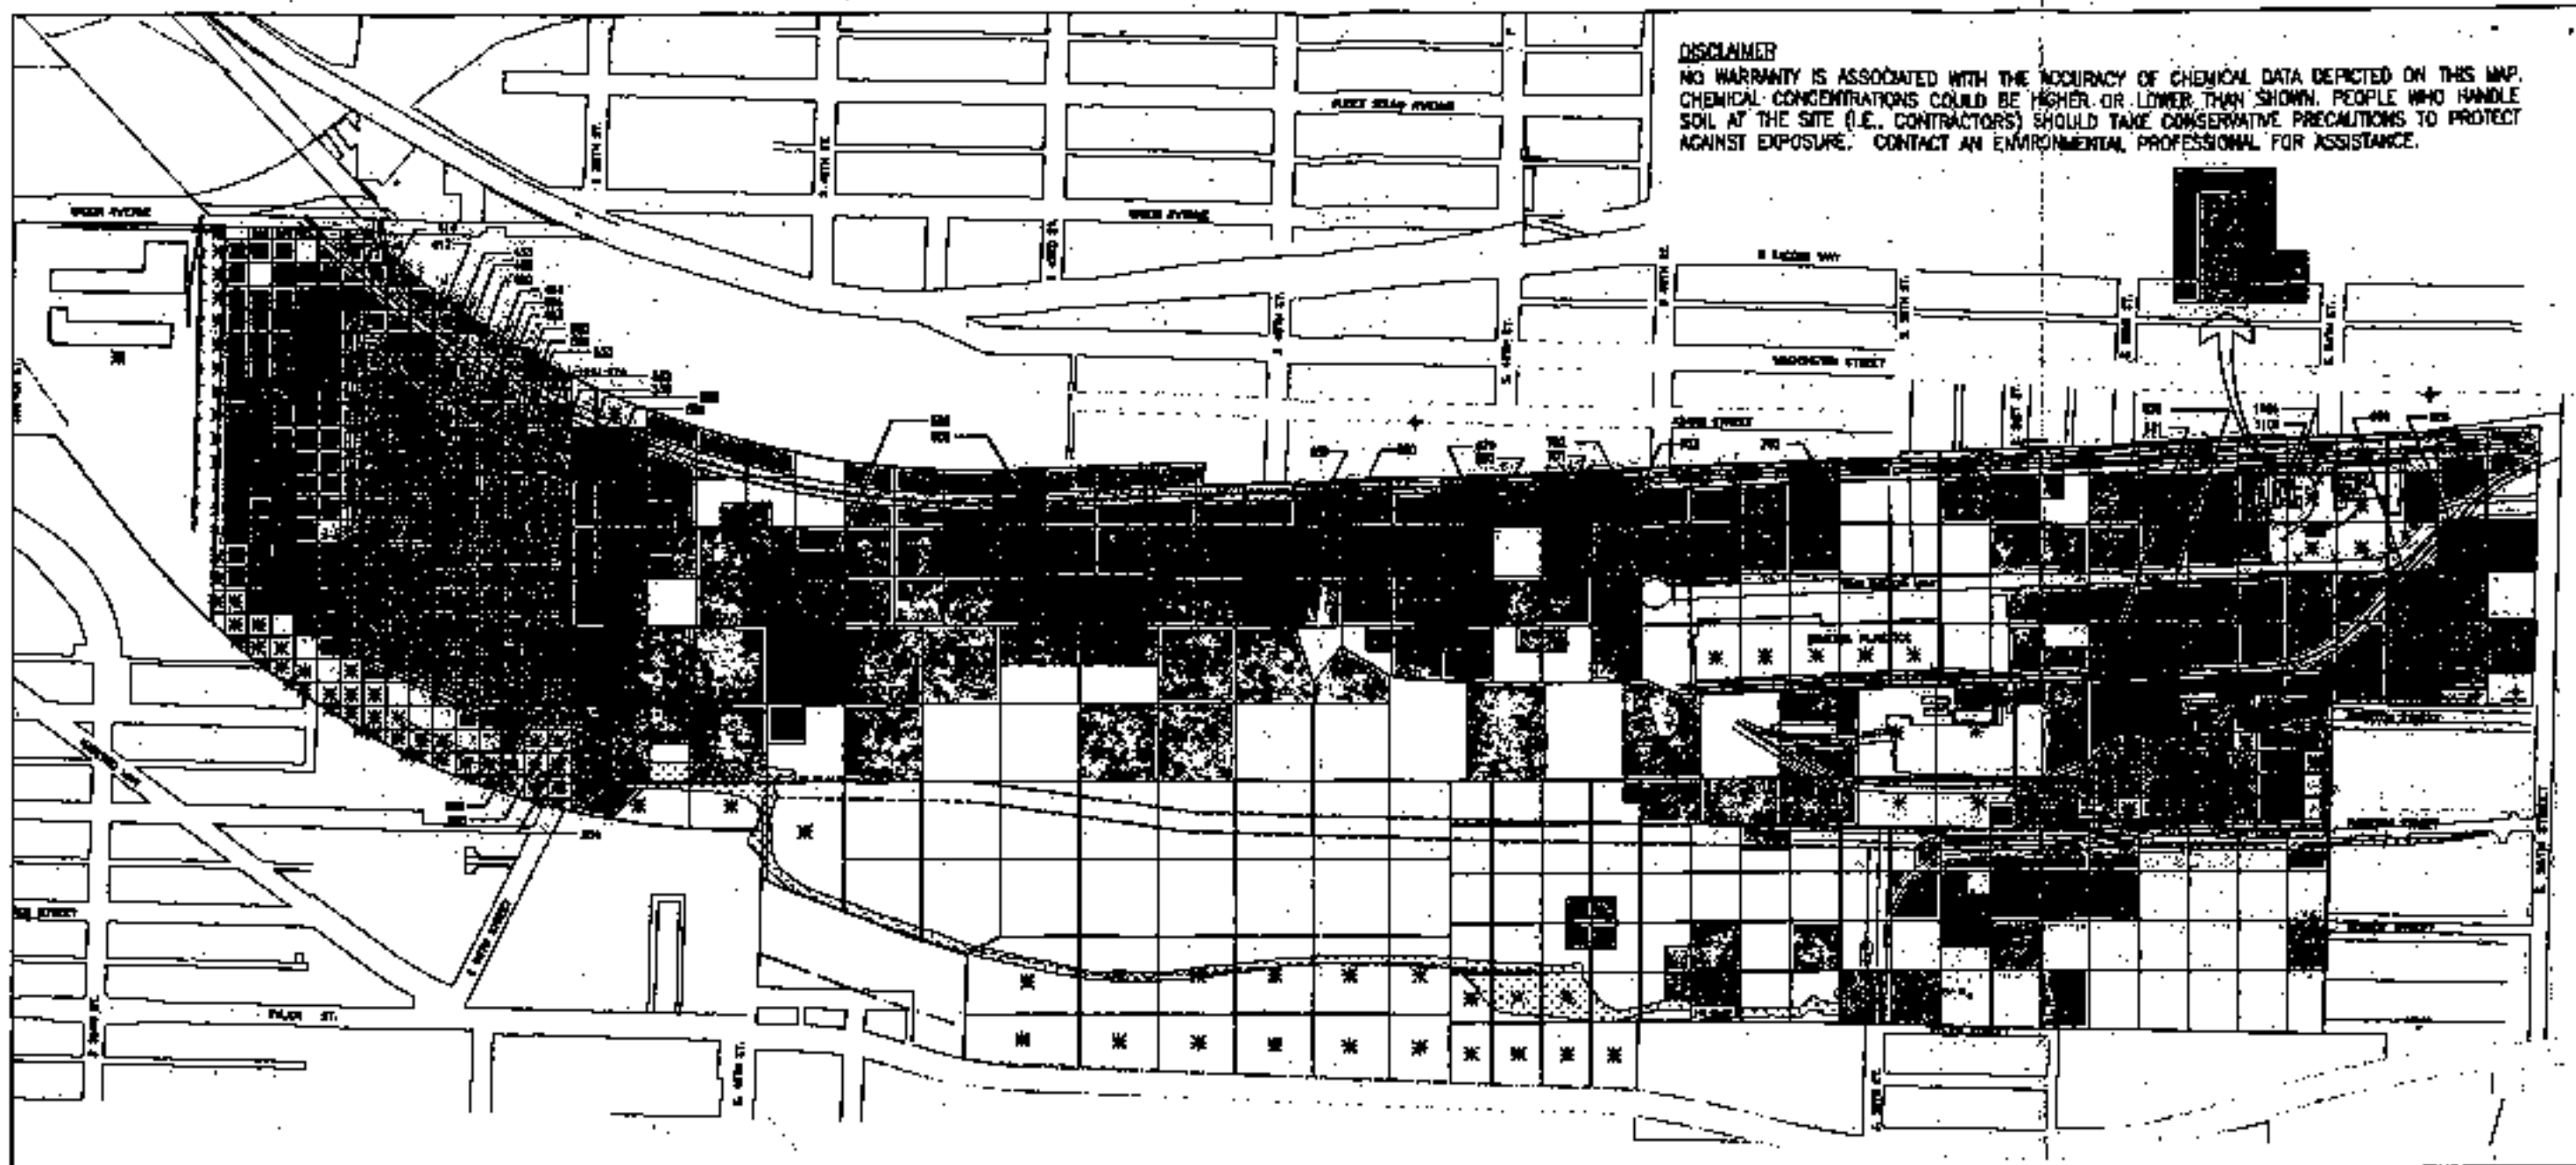
Figure 3

BURIED GEOTEXTILE; IDENTIFIES LIMIT OF TREATED OR CONTAMINATED SUBSURFACE SOIL

ARSENIC 200 mg/kg
LEAD 1,000 mg/kg
Cd+Pb (TOTAL) 20 mg/kg
PCBs (TOTAL) 10 mg/kg
